Job Title
**Northeast Yorkshire Strategic
 Flood Risk Assessment**

Drawing Title
**Existing Flood Risk
 Situation in Old Malton**

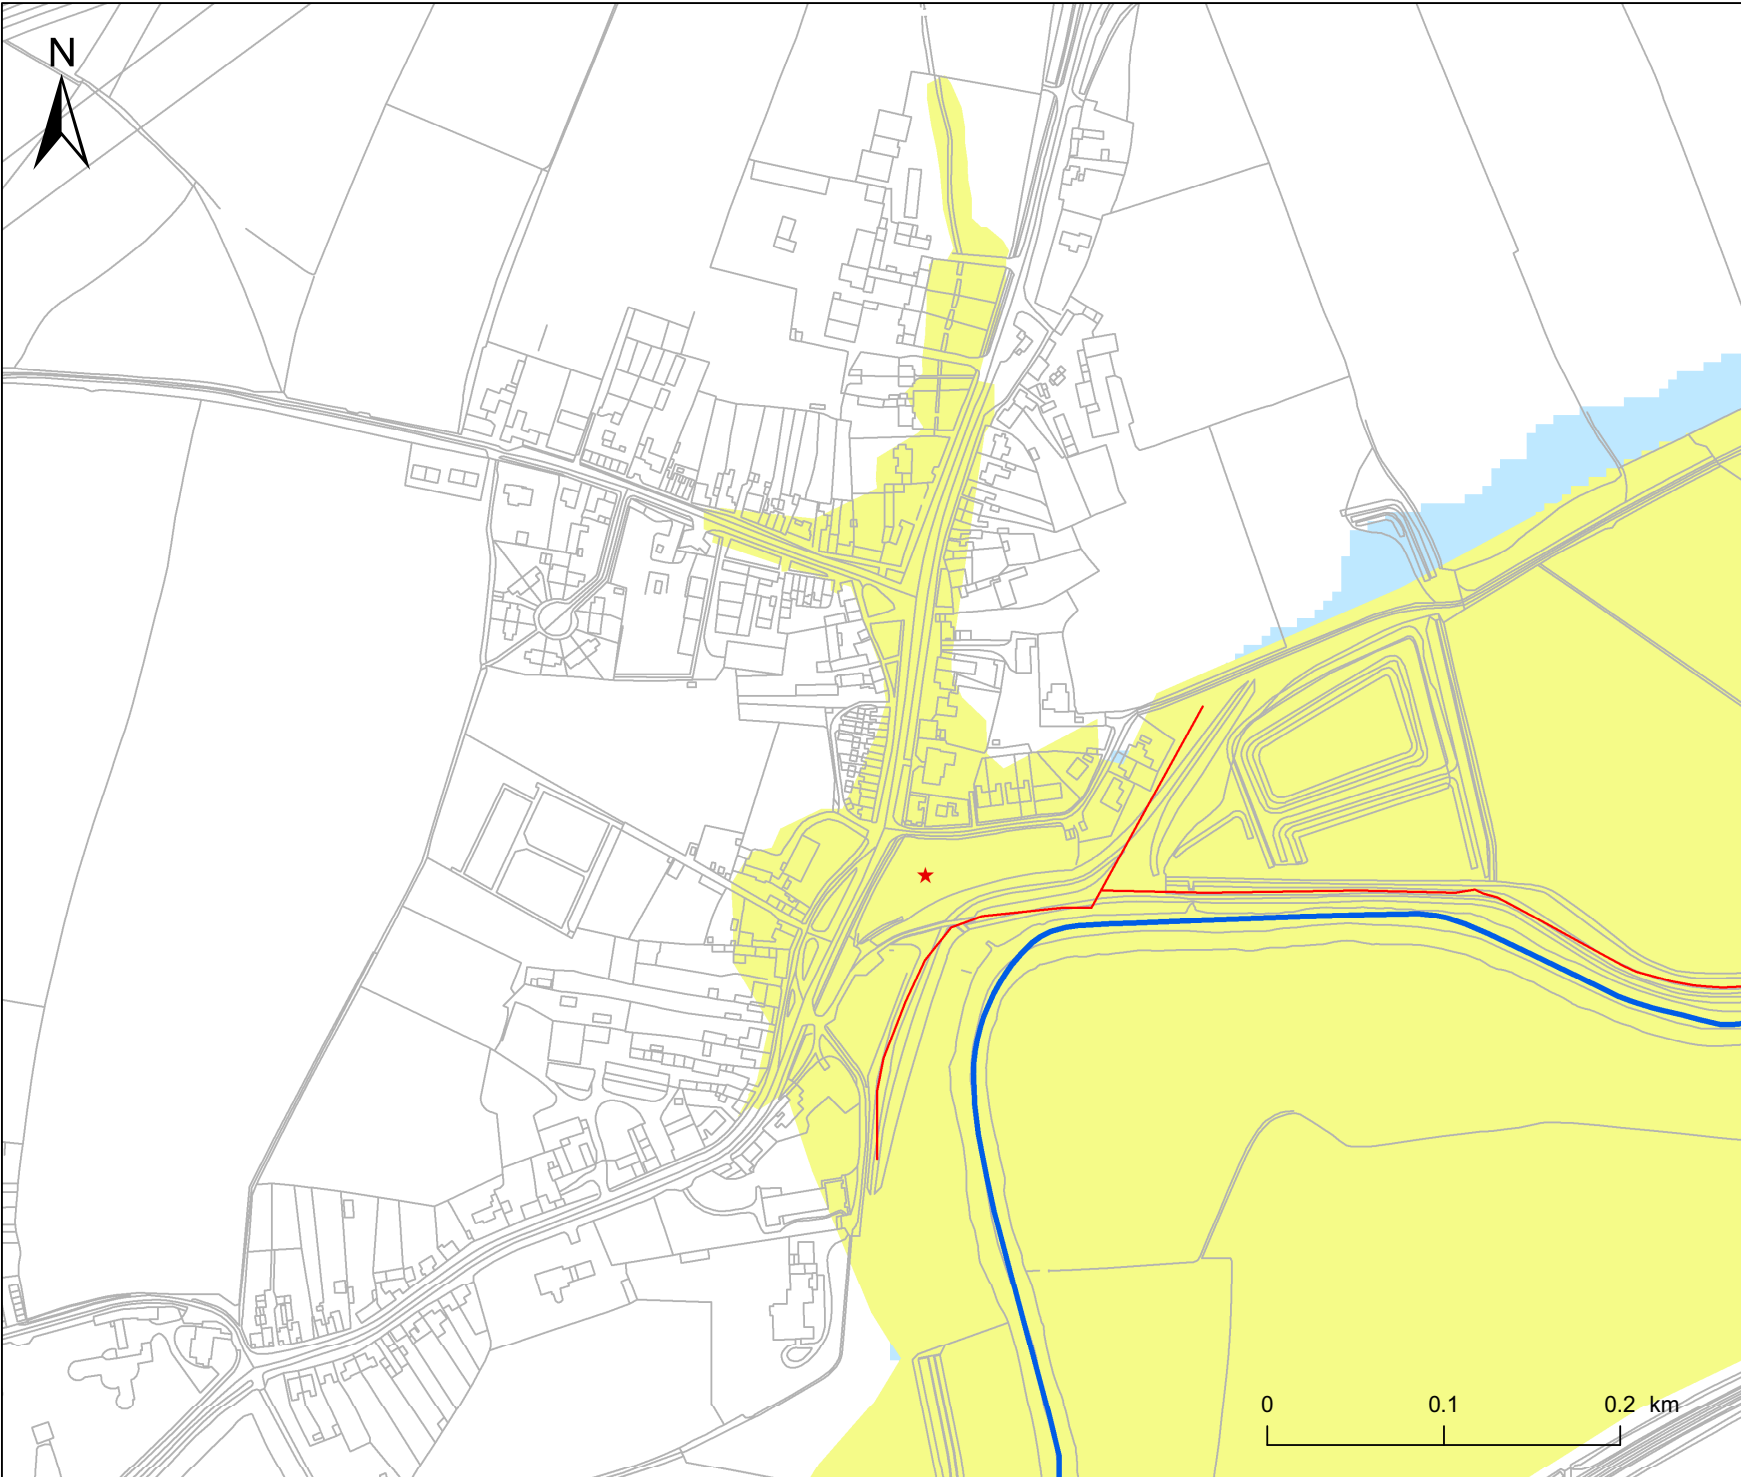
Job No.	Drawing No.	Status
117775	Figure 10.15	ISSUE

2) The locations of reported flooding incidents are based on information from a variety of sources, and the accuracy of reported locations is variable. The reported flood locations shown are only intended to indicate that a reported flood event has occurred within or close to a settlement. This figure should not be relied upon to identify the location within the settlement where a reported event has occurred.
