Job Title
**Northeast Yorkshire Strategic
 Flood Risk Assessment**

Drawing Title
**Existing Flood Risk
 Situation in Pickering**

Job No. 117775	Drawing No. Figure 10.7	Status ISSUE
-------------------	----------------------------	-----------------

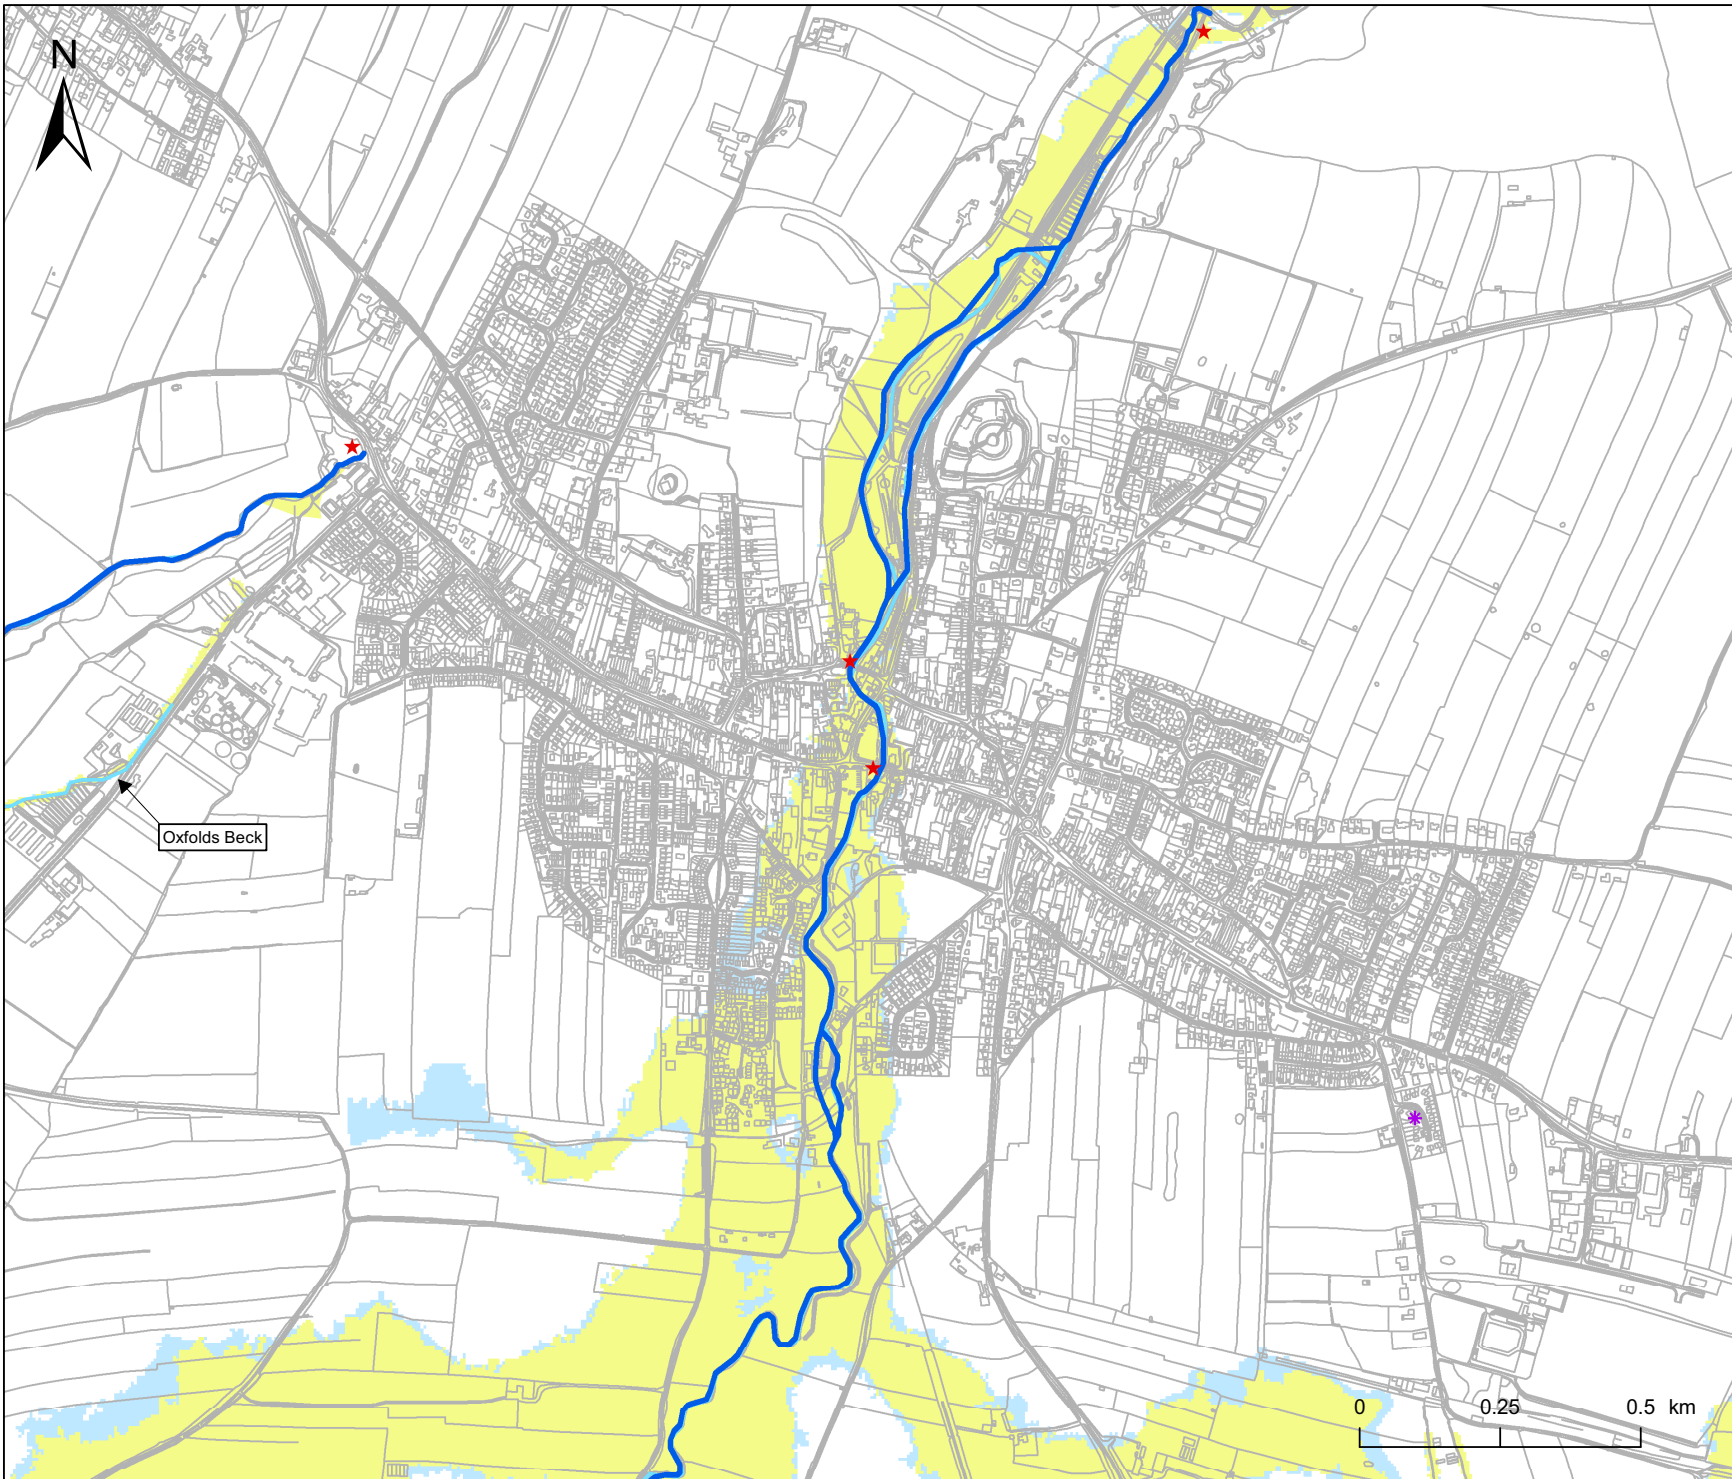
2) The locations of reported flooding incidents are based on information from a variety of sources, and the accuracy of reported locations is variable. The reported flood locations shown are only intended to indicate that a reported flood event has occurred within or close to a settlement. This figure should not be relied upon to identify the location within the settlement where a reported event has occurred.
